Manhole Inspection Summary

Manhole # S13KK1013MH

Location Address: **4500 OAKFORD AVE**

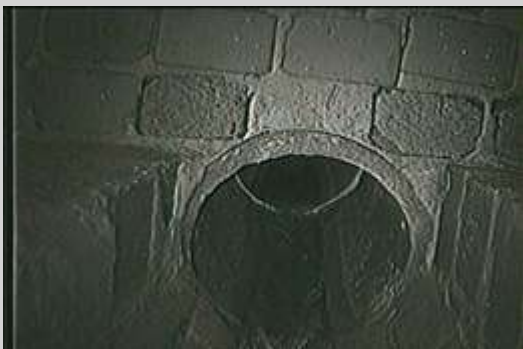
8 in. Circular Gravity Sewer Pipe In @ 4 O'Clock

Rod and Bar (Angled)

Pipe Material: **Clay** ☐ Pipe Lined

Invert Depth: **8.62** (ft.) Flow Characteristics: **Slow**

Deposits: ☒ None ☐ Mud ☐ Sludge ☐ Debris ☐ Grease

Infiltration: **None** Pipe Seal Cond: **Unknown**

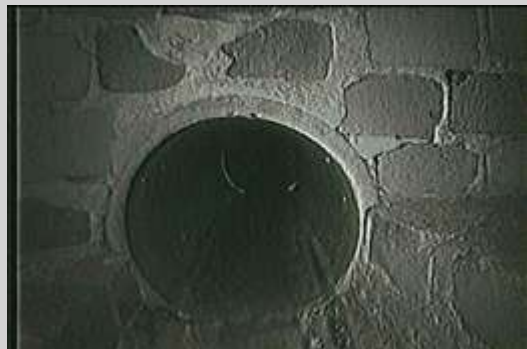
8 in. Circular Gravity Sewer

Rod and Bar (Angled)

Pipe Material: **Clay**

Infiltration: **None**
